EVN AG
Vibration Problem
TG2 2014

Документ №/Dokument-Nr.	Тел. Tel.	Код на проекта /Projektkennzeichen	Дата на издаване / Erstelldatum 03.02.2015	
		Ревизия/Revision B	Страници / Seiten 2	Приложения / Anlagen 6
Заглавие/Überschrift: Visit Report – Balancing LP Rotor				
Изготвил/Erstellt von: Ramon Harps			Дата/Datum 04.02.2015	
Проверил/Geprüft von:			Дата/Datum	
Ръководител проект/Projektleiter:			Дата/Datum	
Отговорни от EBH/EVN Verantwortliche: Krasimir Brandiski		Забележка/Prüfvermerk:	Дата/Datum	
Забележка/Prüfvermerk:				
Одобрение Freigabe	FPL Планировка FPL Gesamtplaner		Дата Datum	
	Техническо ръководство на проекта Technische Projektleitung		Дата Datum

GENERAL

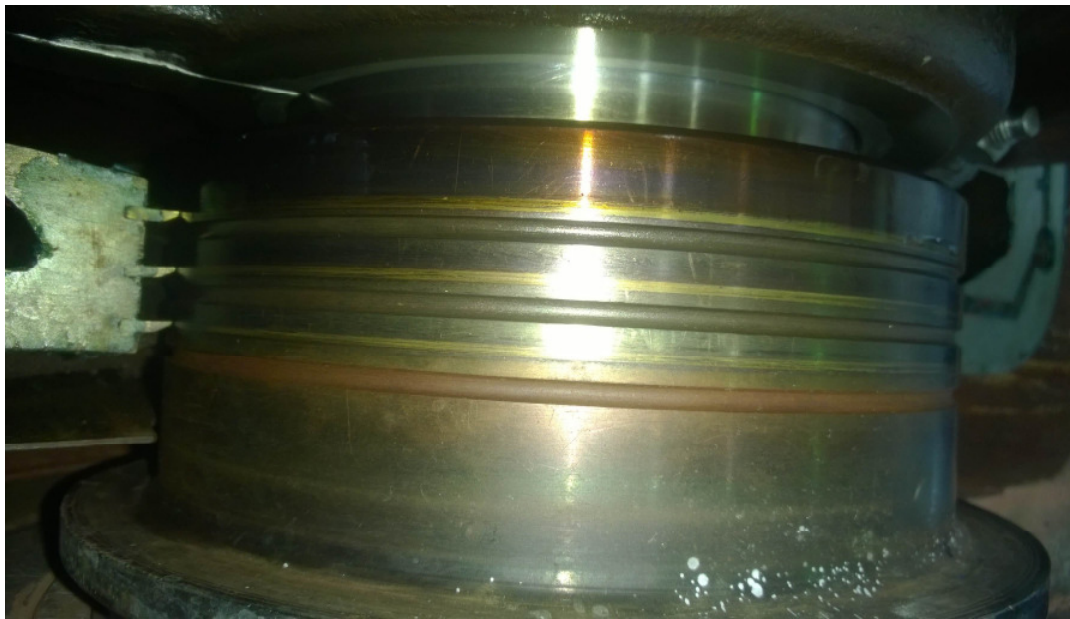
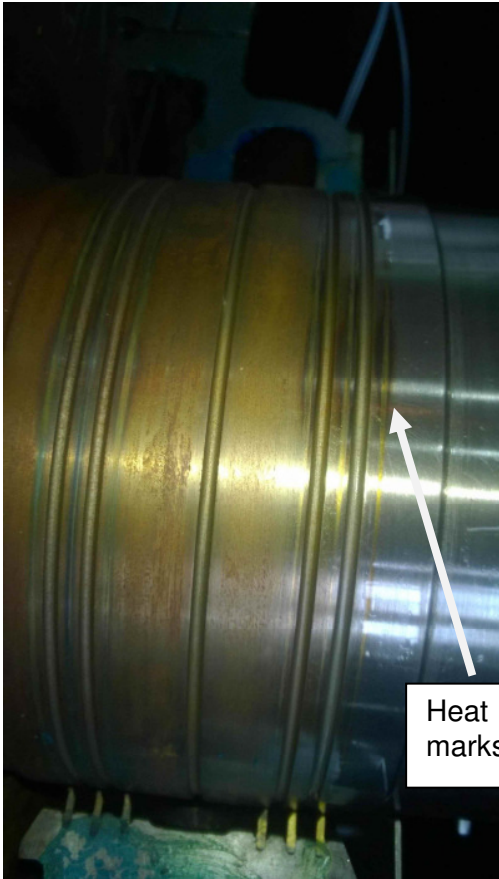
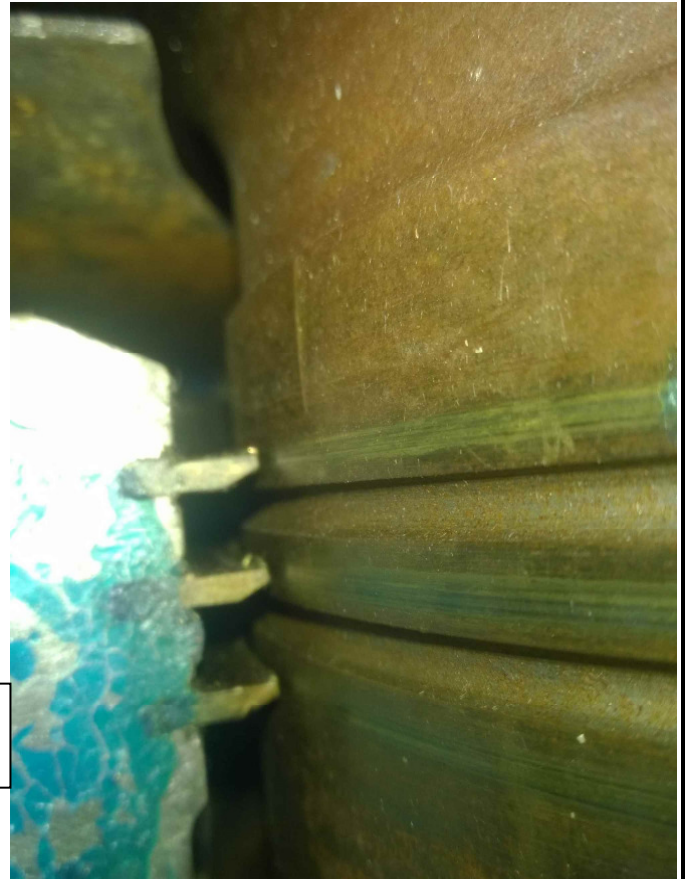
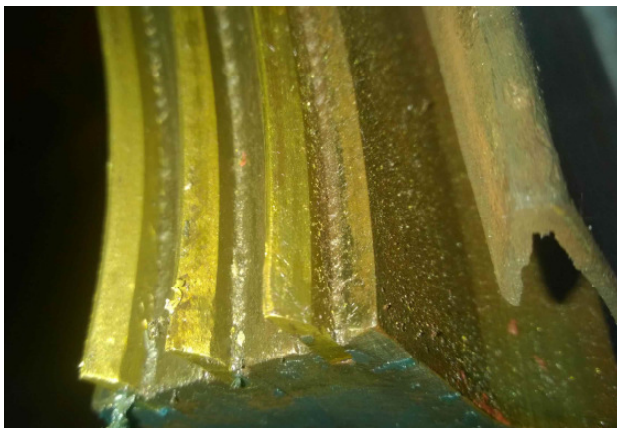
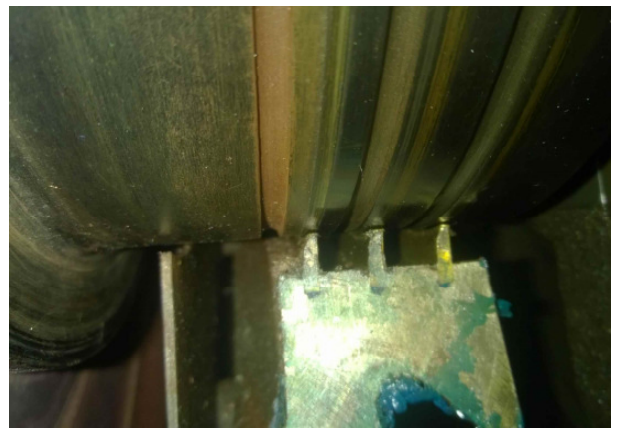
The oil labyrinth seals at bearing 1, left and right from coupling HP/LP rotor and left and right from bearing 2 have the same picture:

Strong wear on the sealing ring tips, strong rubbing marks on the rotor.

The rubbing marks are not constant around the circumference at coupling and at bearing 2. At bearing 1 the rubbing marks are nearly even on 360° of the rotor.

In some areas it seems that local heating left colored marks (may be misleading, as there are many effects, coloring the rotor).

The only finding, which normally is not presented in operated steam turbines, is the rubbing of the oil seals on the rotor. The rubbing is considered as significant – the marks cannot be seen as slight or not relevant!

The oil seals rings from brass have much smaller clearance than the bearings, which led to rubbing at the rotor – proven by the severe rubbing marks on the rotor and on the brass rings.

1. All damages of the rotor should be repaired, clearances on steam labyrinths should be rechecked for improvement (0,35 is as well less than bearing clearance!??)
2. Bearings clearance und oil seals clearance should be rechecked. Probably oils seals should have same or 0.05 bigger clearance than bearings. At the coupling even more!
3. Assembly with alignment together with LP rotor and generator rotor
4. During start up after assembly additional vibration measurement

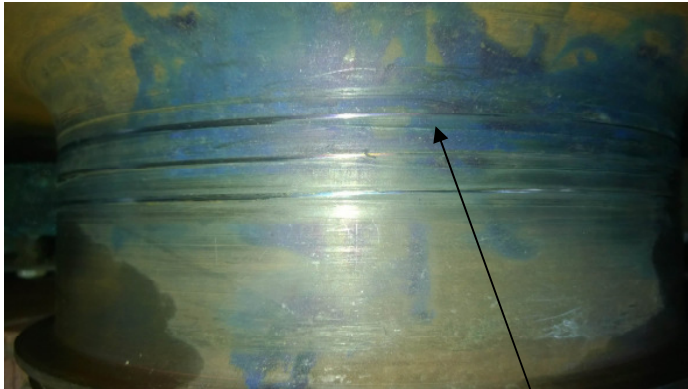
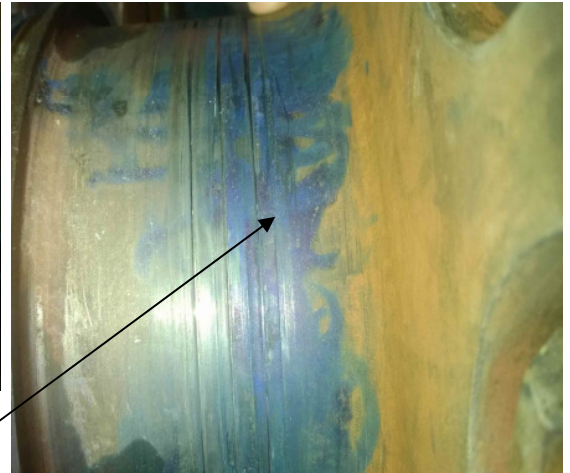
At the HP/LP coupling on the HP side even grooves on the rotor are visible. See photos below

Oil labyrinth marks at coupling

Deep grooves, inside not shiny
=> older, but after overhaul 2013!!

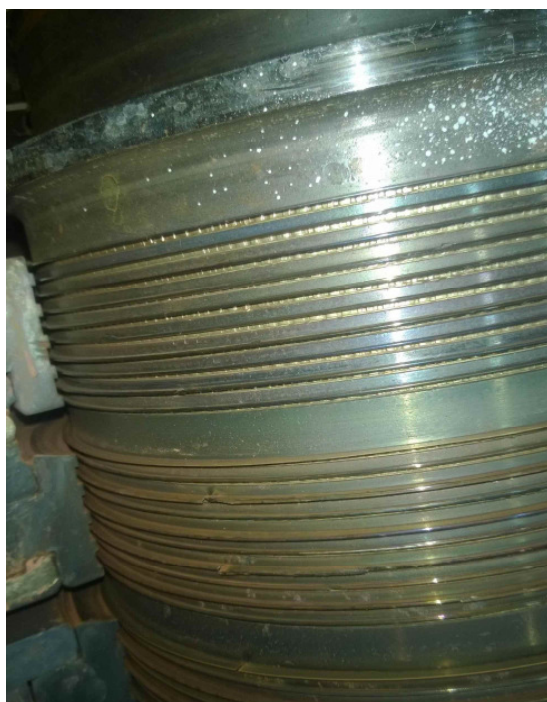
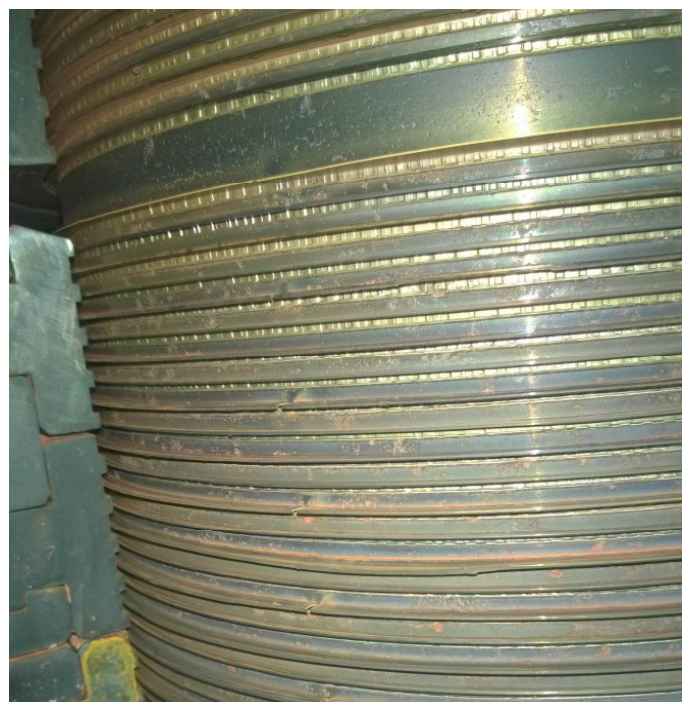
All labyrinth seals have rubbing marks. In some areas they are strongly bended and deformed. In general close to the bearings, the labyrinths are in better condition, the severest damages are at the balance piston
See photos below!

Steam labyrinth sealing - bearing

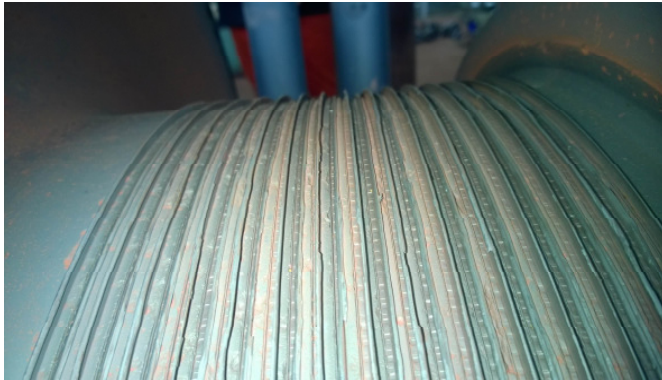
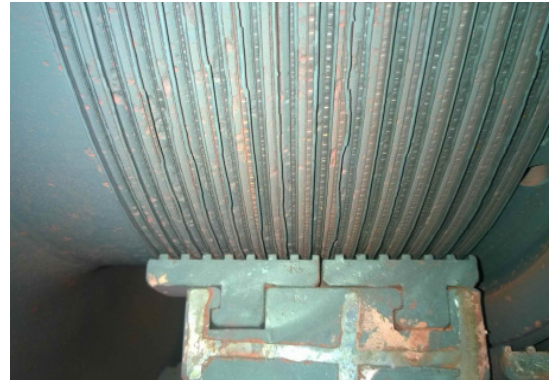
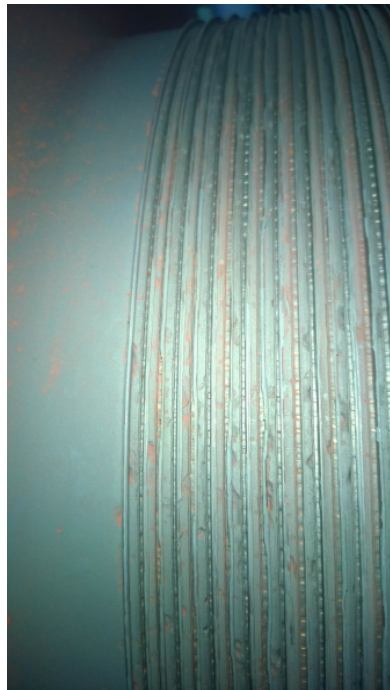
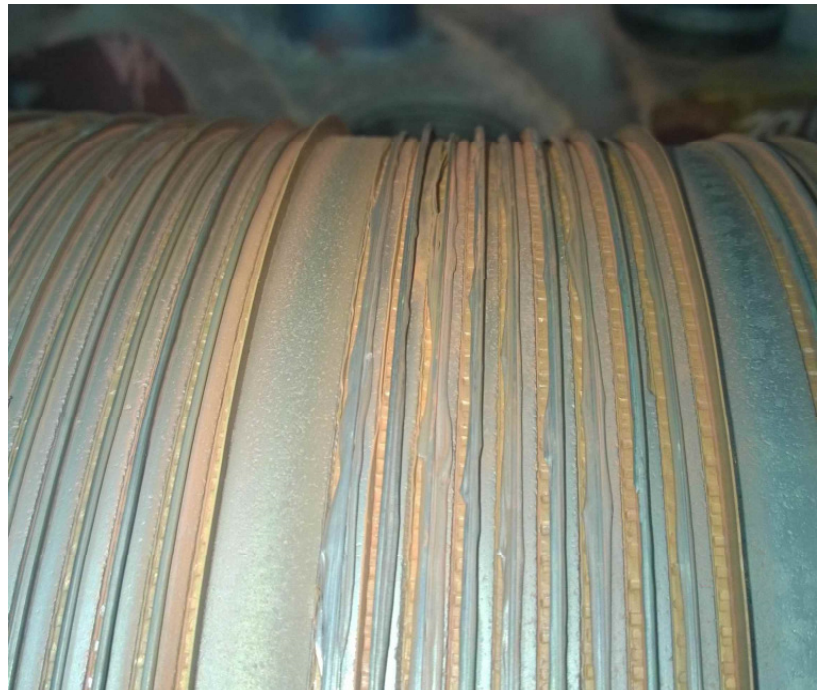
Labyrinth sealing – balance piston

Turning the rotor the severest damages correspond with the strongest rubbing marks of the oil labyrinths.

This is a hint, that the rotor bends before rubbing – not the casing.

On the photo right, there are new rubbing marks of the labyrinth seals close to the horizontal joint.

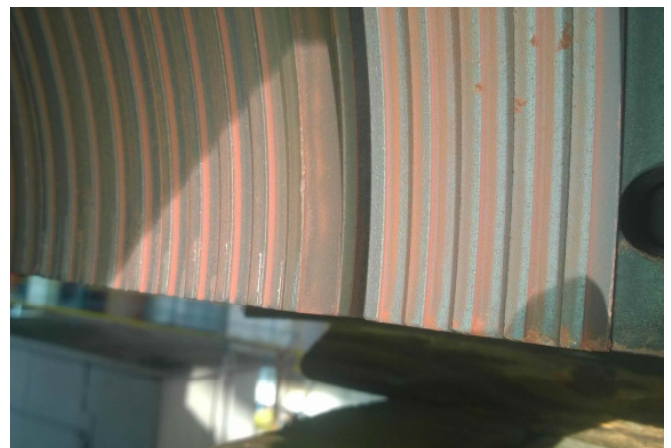
In the top of the stator no such rubbing marks could be seen.

This rubbing marks are not considered as dramatic, this means they could appear in any turbine running without problems.

Labyrinth sealing - stator

5. The lower stator parts may be lowered by 0,05 to 0,1 mm, because steam labyrinth seals had rubbing marks at the bottom, but no marks on the top.
6. Because the given explanation is not 100% sure, the rotor could be checked for balancing and cracks.

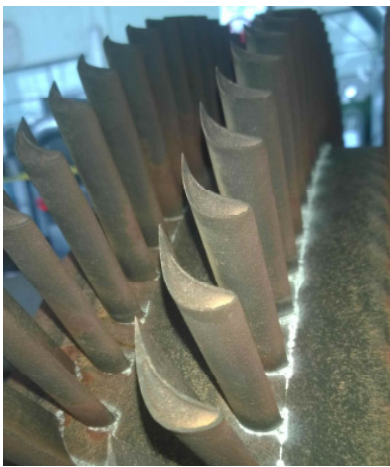
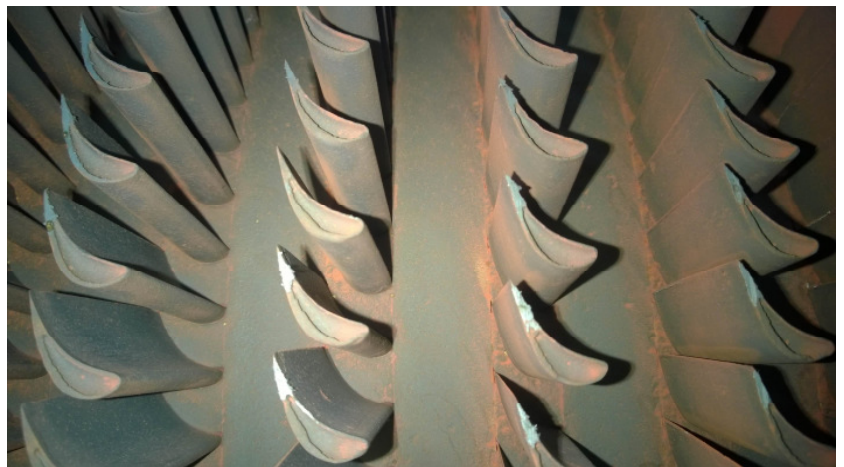
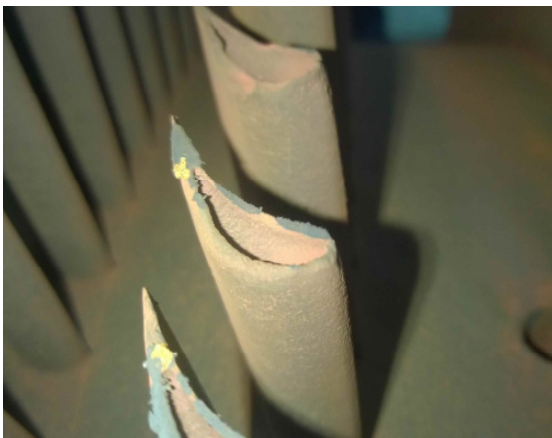
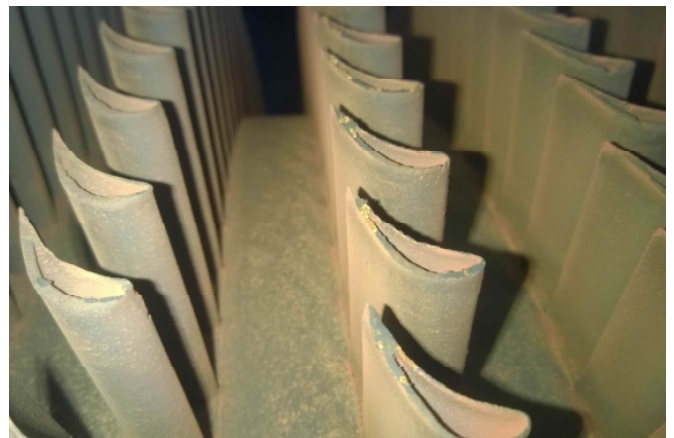
Even though in the middle part of the hp rotor (from stage 1 to 25) had clear rubbing marks of the blade tips. In the center of the rotor the marks were strongest and on circumference the biggest number of blades were affected.

This means as well the blades give the clear picture of a bended rotor in the moment rubbing happens – not a buckling casing.

On the upper left photo the stages 29 und 30 can be seen. They have no rubbing marks, as they are very close to bearing 1.

On the blade tips the shiny marks show rubbing during the last operation. Other not shine rubbing marks may have happened weeks or as well years ago. This cannot be identified at the moment. These not shiny marks could be fined on any blade, there is no structure for distribution on the HP rotor.

As well on the upper left photo white marks (like salt) at the blade foot are visible. This means there is an issue with steam quality. Such marks in the HP part of a steam turbine are not common.

Some blades (2 or 3) were found bended as a whole. The position of these blades were not corresponding with the rubbing marks.

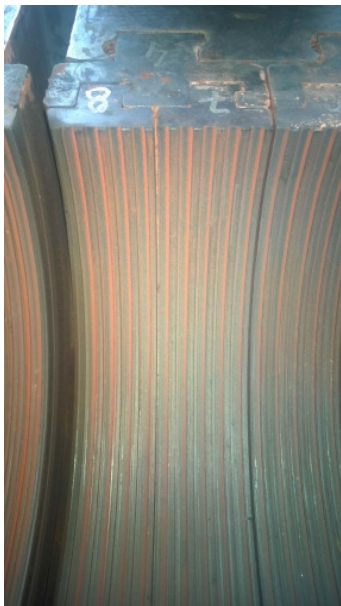
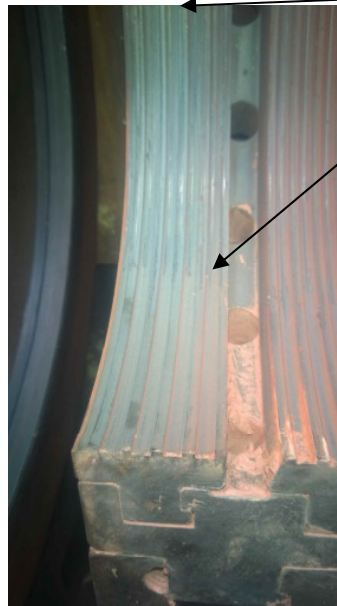
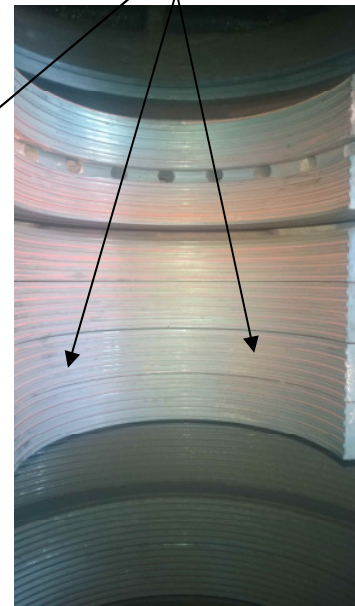
The stator of the labyrinth seals at bearing 1 shows slight rubbing marks in 180° position.

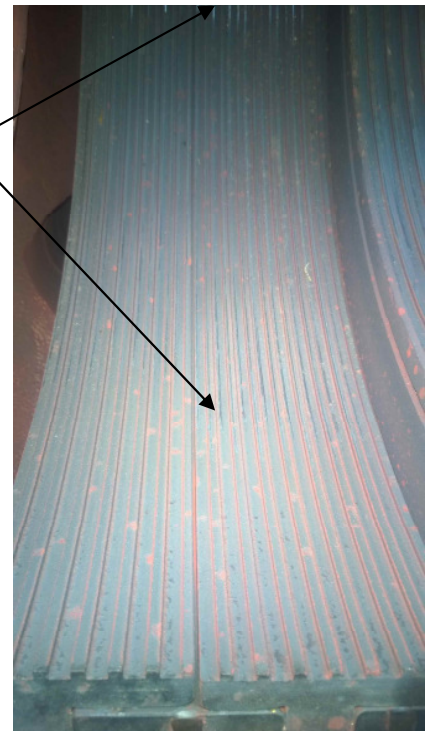
The stator of the labyrinth seals at the balance piston has well fresh rubbing marks only at a segment center down.

The marks are very thin. They are not considered as dramatic.

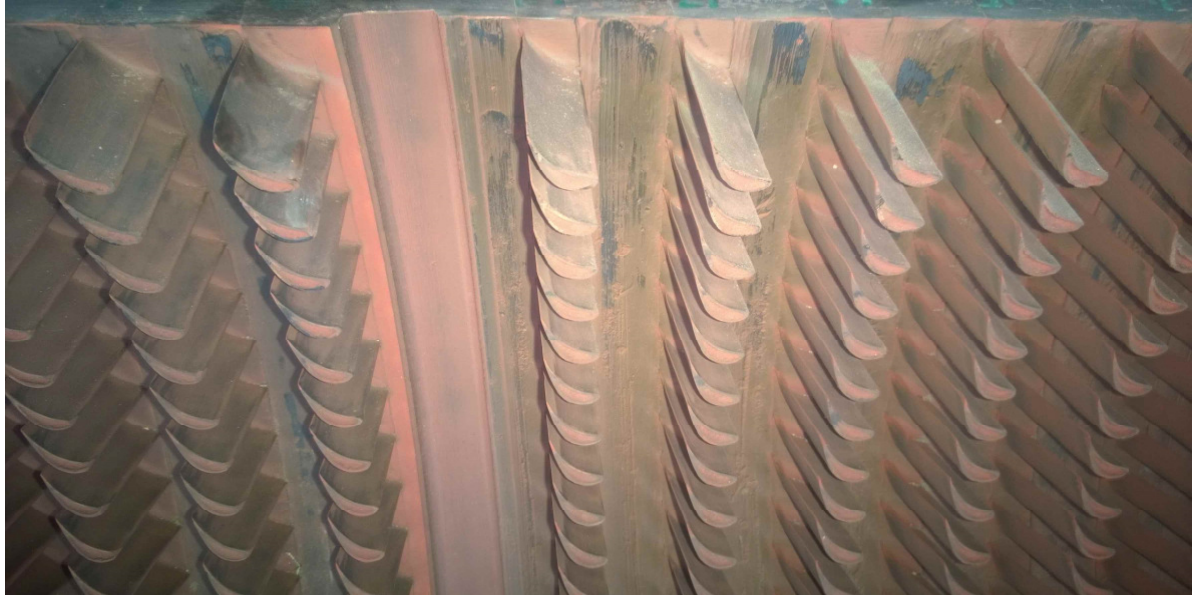
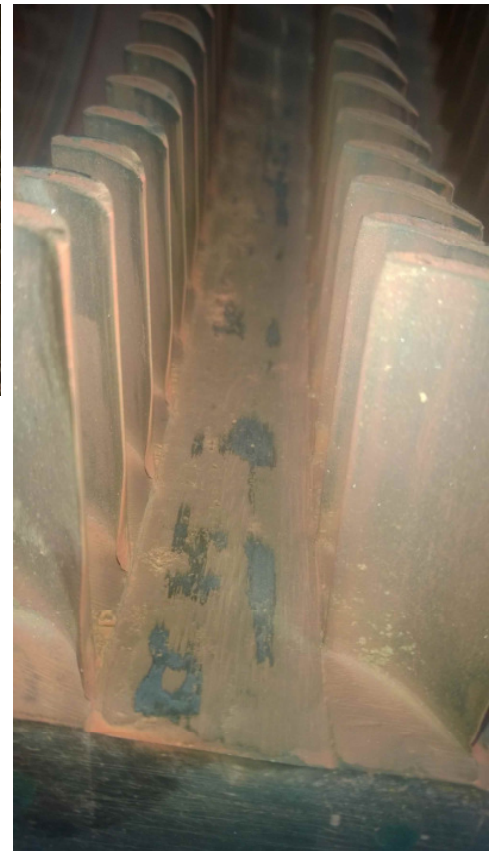
A different picture show the rubbing marks from the rotor blades in the lower half of the HP casing. Marks at the left side (looking direction LP steam flow / generator) are dominating, see following photos.

Lower HP casing - Left side

The rubbing marks do not show the typical picture of a casing, which is buckling due to uneven top / down heating during start up, because they do not appear at the bottom center but on one side.

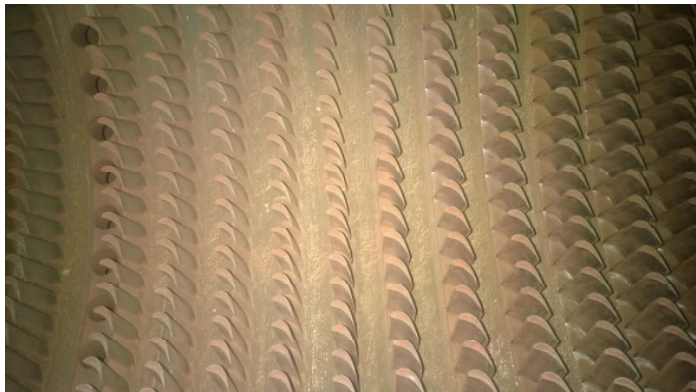
Lower HP casing – center down

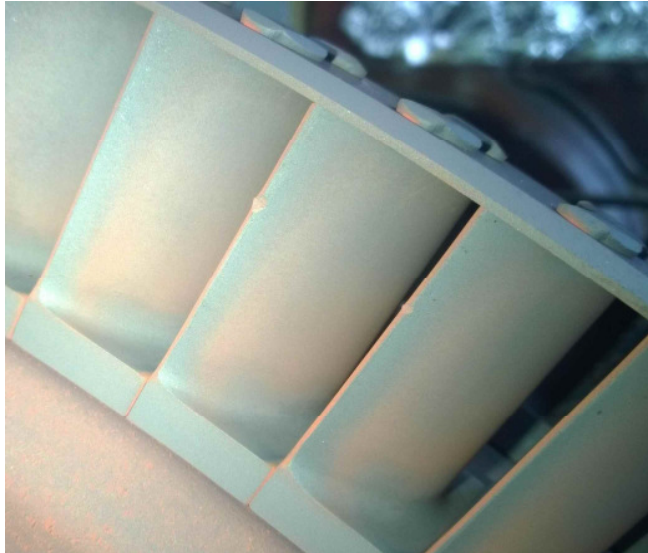
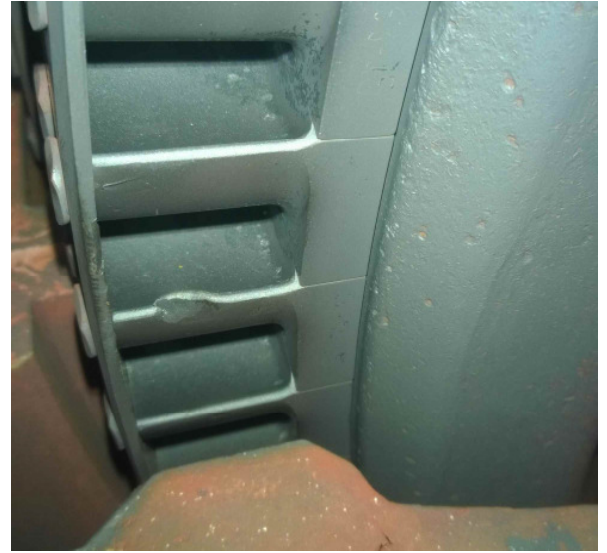
Some defects from not clean steam were found, photos below.

Control stage HP rotor

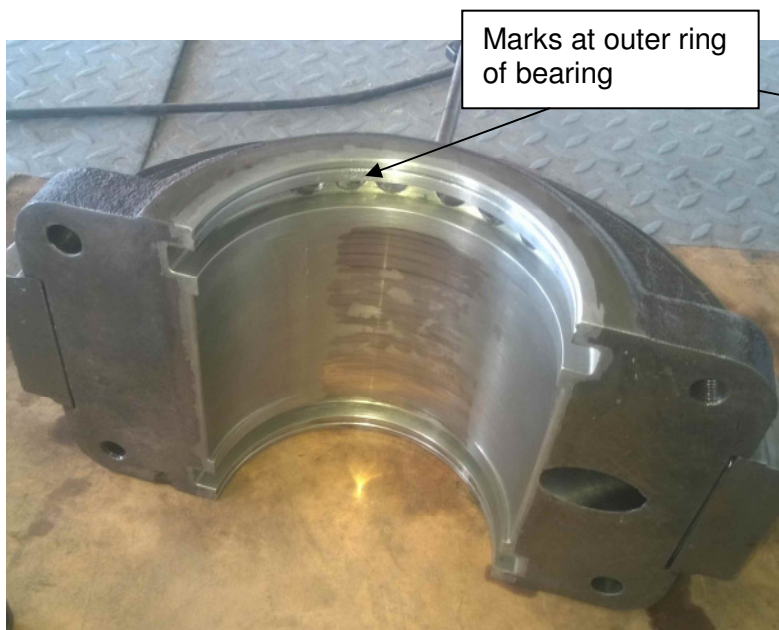
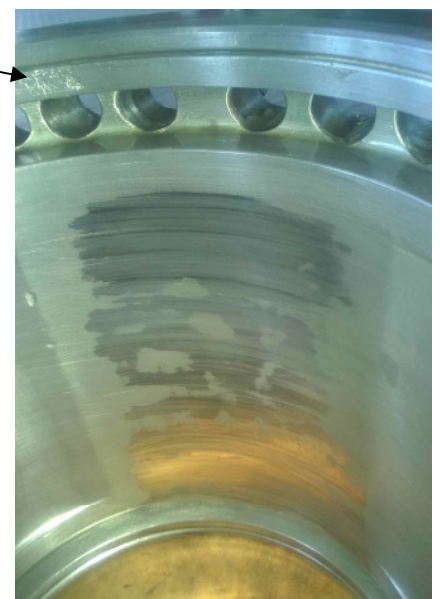
The bearing looked in general not like new, but ok. The rubbing marks at the lower half could be the result of many start stop operations and operation in turning gear with not sufficient oil supply, which is normal for such systems without jacking oil.

Bearing 1 – lower half

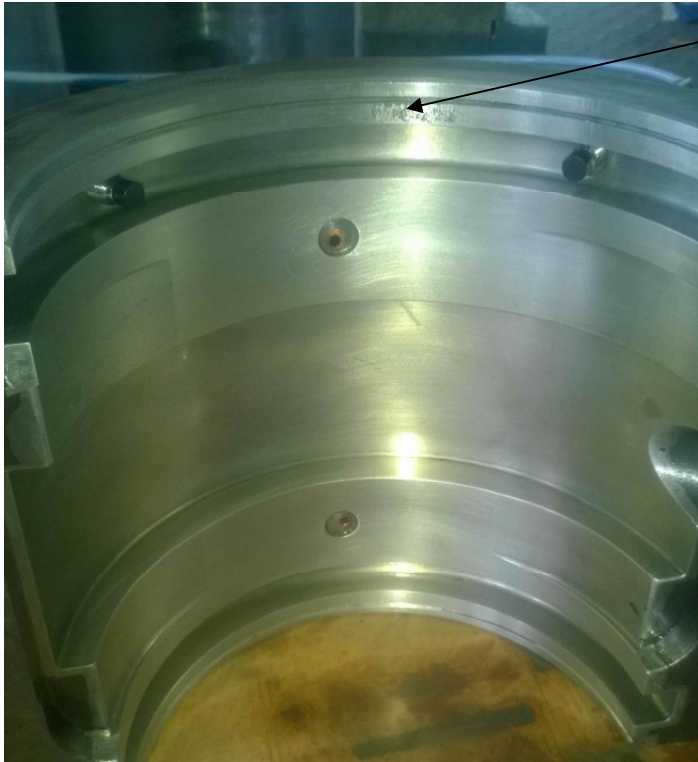
Marks at outer ring
of bearing

There are some marks at the outer ring of the bearing, but not considered as relevant impact to vibration.

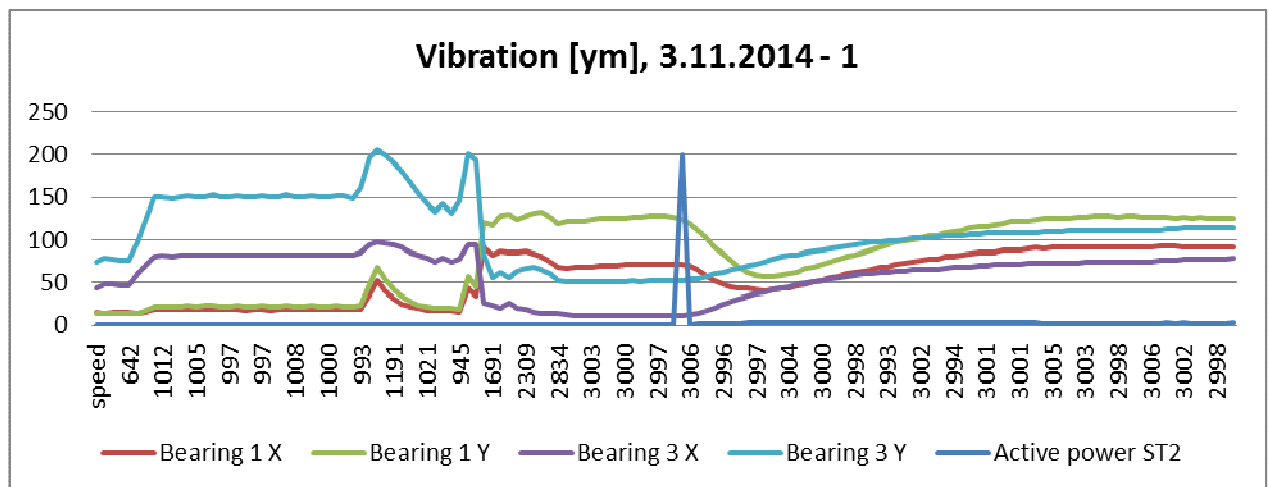
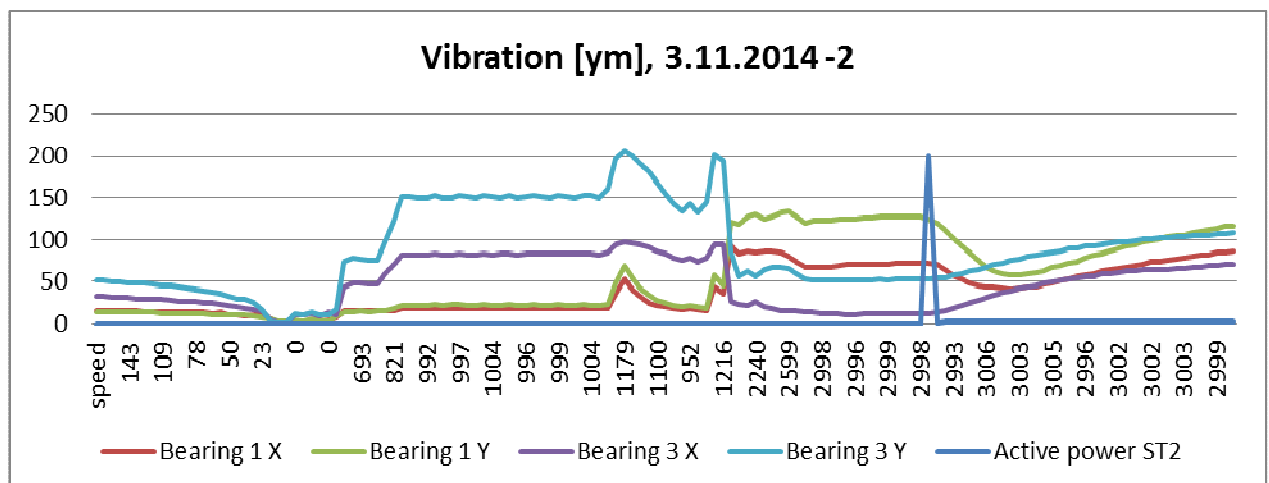
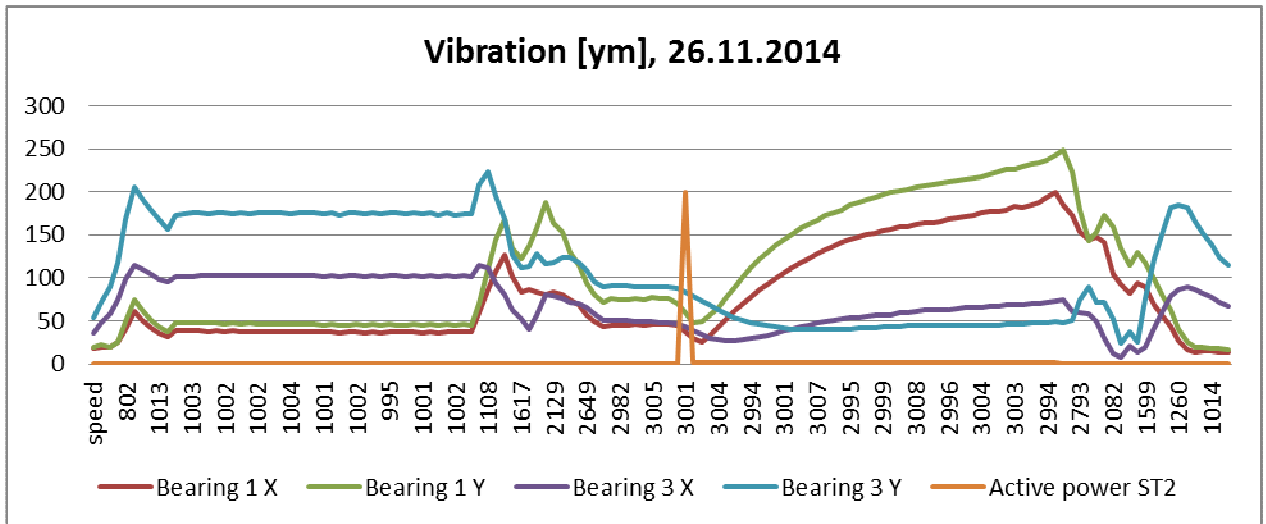
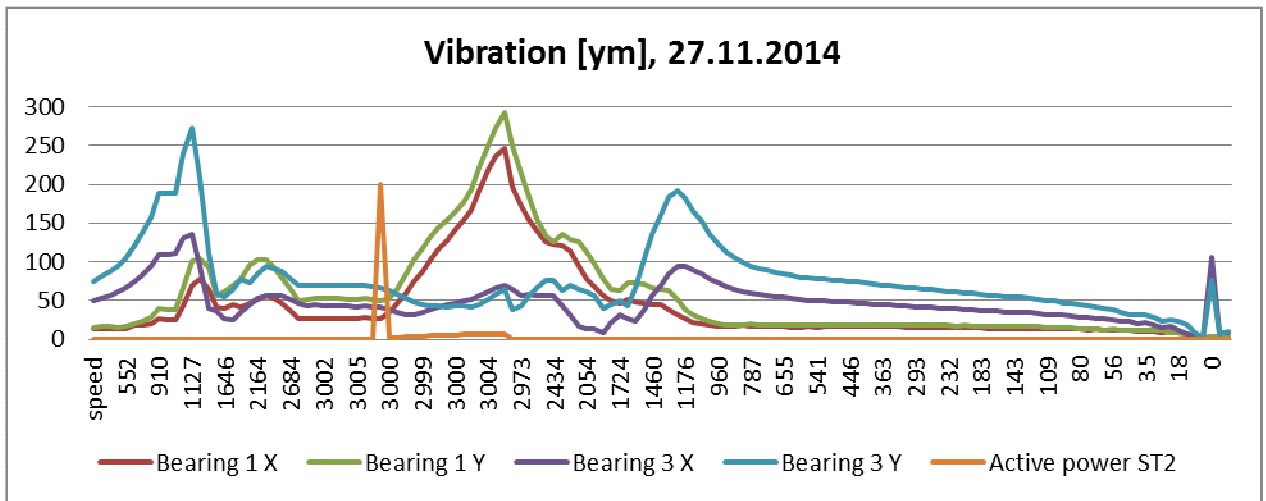
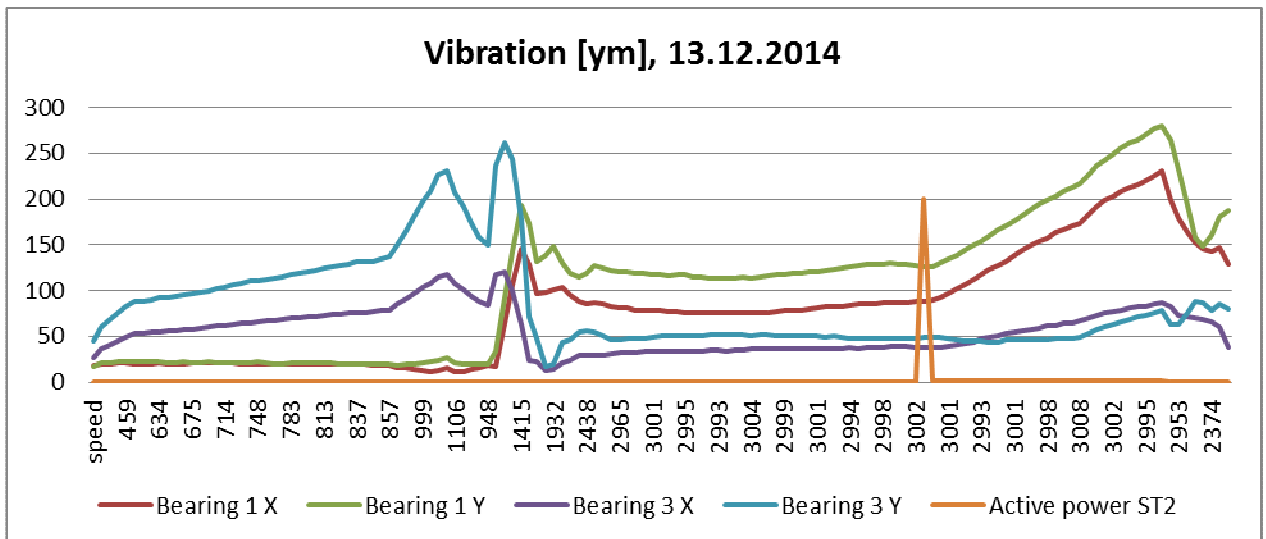
Comparing the values at the different dates show on 3.11. and 13.12. nearly the same picture, bearing 1 between 70 µm and 130 µm, bearing 3 close or below 50 µm. On 26/27 the values for bearing 1 are even lower, for bearing 3 a little higher. The run out correction before the 13th at bearing 1 seems to have very small effect.

a worsening of the situation may be observed. On 3rd bearing 3 reaching around 200 µm, on 26th 220 µm up to 270 and 260 µm on 27th and 13th.

But an unclear picture is given by bearing one, on 26th and 13th relatively high, but on 27th and 3rd very small!

On 3rd the vibration in bearing 1 going first down and then slightly increasing up to a value of 120 µm

On 26th in general the same behavior can be observed, but the increasing after going down is not so smooth any more, seems to stabilize, but then finally just not manages to stabilize.

On 27th the picture looks much more drastic, but on this trial the load after synchronizing were increased faster – as a consequence the vibration went up faster - no chance!!

On 13th as well directly up after synchronization, no hint for stabilization but quite slower increase compared with 27th as well load were not increased so fast.

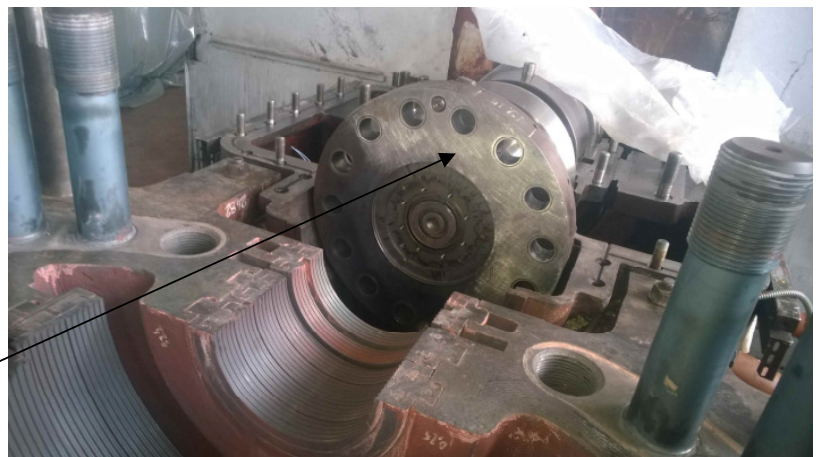
On 30th Nov. 2014 the alignment of the HP Rotor where checked, It was found that the radial run-out at bearing 1 was up to 0,28 mm. By shaping the coupling at bearing 2 the run-out was corrected to a range of 0 to 0,01 mm. (Att2. *Coupling-check-prot*) See corrected area at the coupling in photo right!

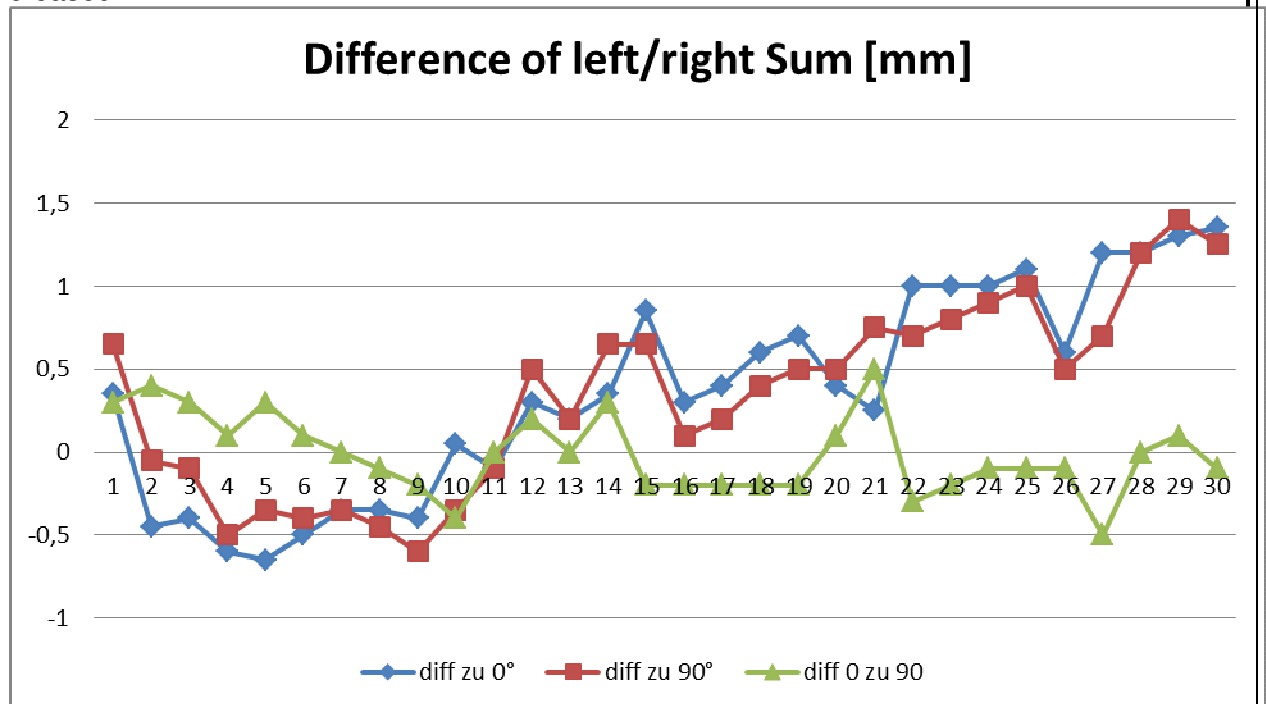
Obviously the effect of uneven blade length and error from measurement is bigger than any

real effect of increase of clearance. So result is "No Result!!

The green line shows the difference between the sums of left/right clearance at 0° and the sum of 90°. Ideally it should be a line at zero, but alternations are significant.

The variation on clearance from blade to blade is probably the reason.
